HISTORIC STRUCTURE REPORT CCC BUILDINGS

1988

CCC BUILDINGS
BANDELIER NATIONAL MONUMENT · NEW MEXICO

UNITED STATES DEPARTMENT OF THE INTERIOR / NATIONAL PARK SERVICE /
DENVER SERVICE CENTER

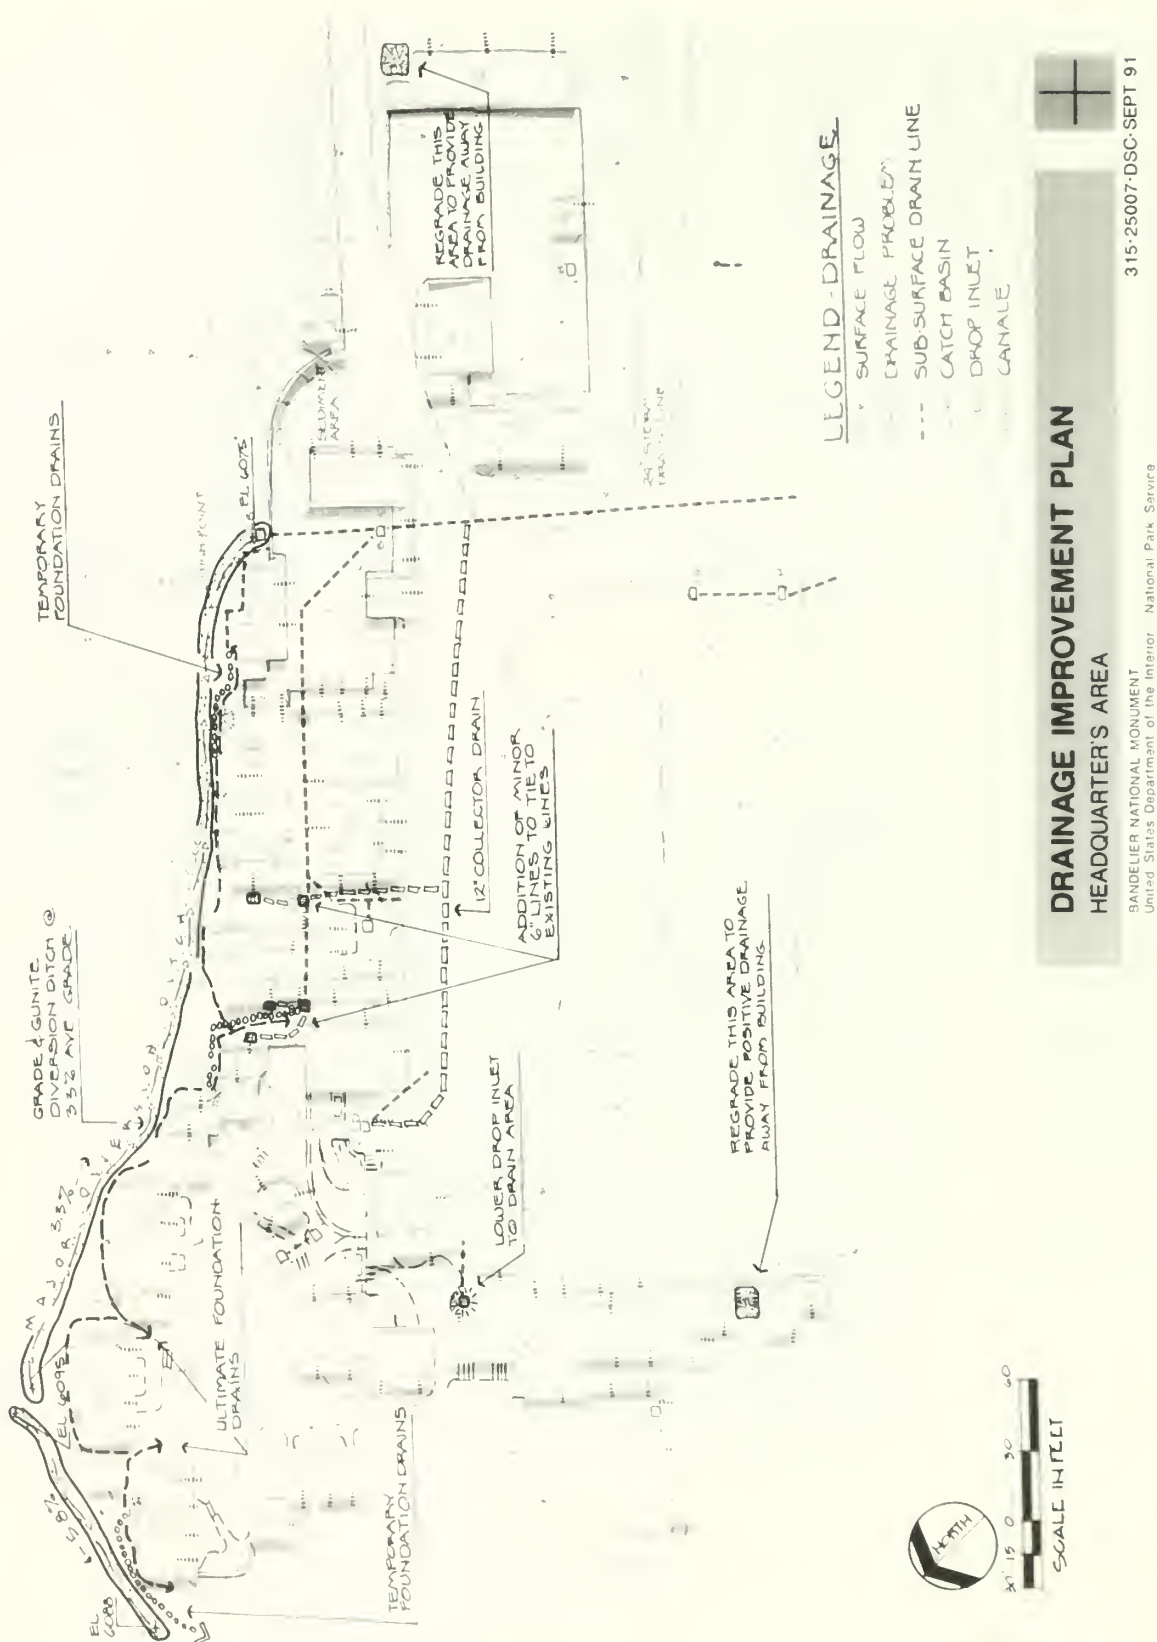
Recommendations to improve drainage and alleviate deterioration of building walls focus primarily on the north (uphill) side of the compound. These recommendations include improving the major diversion ditches, regrading problem areas, containing canale and roof runoff near the diversion ditch, possibly installing foundation drains, and improving minor (6-inch) subsurface drain lines (figure 195). These recommendations are based on a cursory study only. Before any final design recommendations are

In several areas such as B-6, B-2, and B-23, regrading will take care of wet wall problems. Surface drainage seems to function effectively with only minor sedimentation problems.

Figure 195. Drainage improvement plan map.

The diversion ditch is needed primarily for major downpours (figure 196). Regrading to a consistent slope and waterproofing with a Gunit-type surface would enable this ditch not only to handle major downpours and minor surface water but also to carry roof drainage safely away from the buildings (figure 195). With increased flow in the diversion ditch, a small maintainable setting basin would be needed downstream above the catch basin. Talus slope creep will always be a problem to grounds maintenance. Concrete coating or "Guniting" the ditch will at least direct the flow of loose particles and make removing them easier. A more detailed study by a geotechnical engineer could show the need for walls, gabion treatments, forced revegetation, and irrigation. Because the upslope of this headquarters area is a maze of buried utility lines, any excavation will undoubtedly be done by hand.

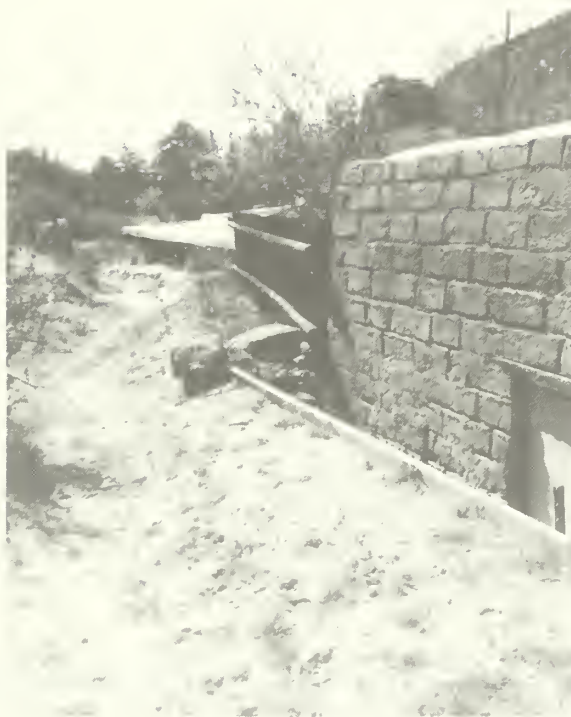
Figure 196. View of 1940 diversion ditch. Porous soil allows very little water to follow the ditch.
